TEST AND EVALUATION OF A SPAR-TYPE OCEANOGRAPHIC BUOY

JULY 1969

NAVAL OCEANOGRAPHIC OFFICE WASHINGTON, D. C. 20390

INFORMAL REPORT

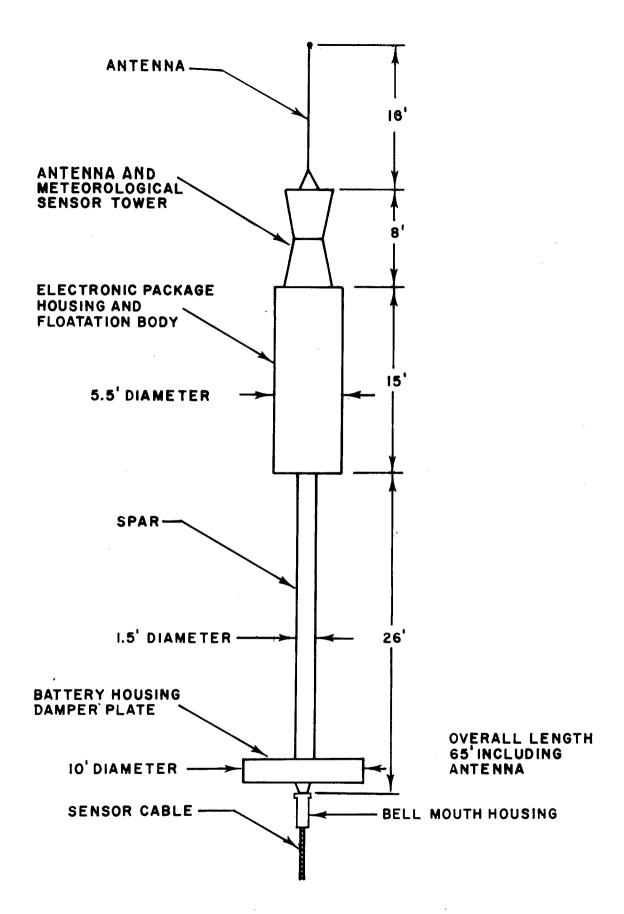
FIGURE 2 LITTON BUOY DIMENSIONAL ENVELOPE

The buoy assembly (figure 2) consists of an aluminum float (15-foot length, 5.5-foot diameter), a damping disc/battery housing (10-foot diameter), and an interconnecting spar (26-foot length, 1.5-foot diameter). An 8-foot instrument mast, which supports a 16-foot marine antenna, is affixed to the upper buoy body. The overall buoy length, not including the antenna, is 49 feet. The buoy weighs approximately 10,000 pounds and has a total reserve buoyancy of 20,000 pounds.

example, spar strength could be doubled by increasing the skin thickness to six-sixteenths of an inch at a weight increase of 500 pounds or 5 percent. Another design recommendation would locate the protective high-pressure hose sheathing of the power cables and battery vents snugly against the buoy structure. These hoses should be housed within metal tubing throughout their length.

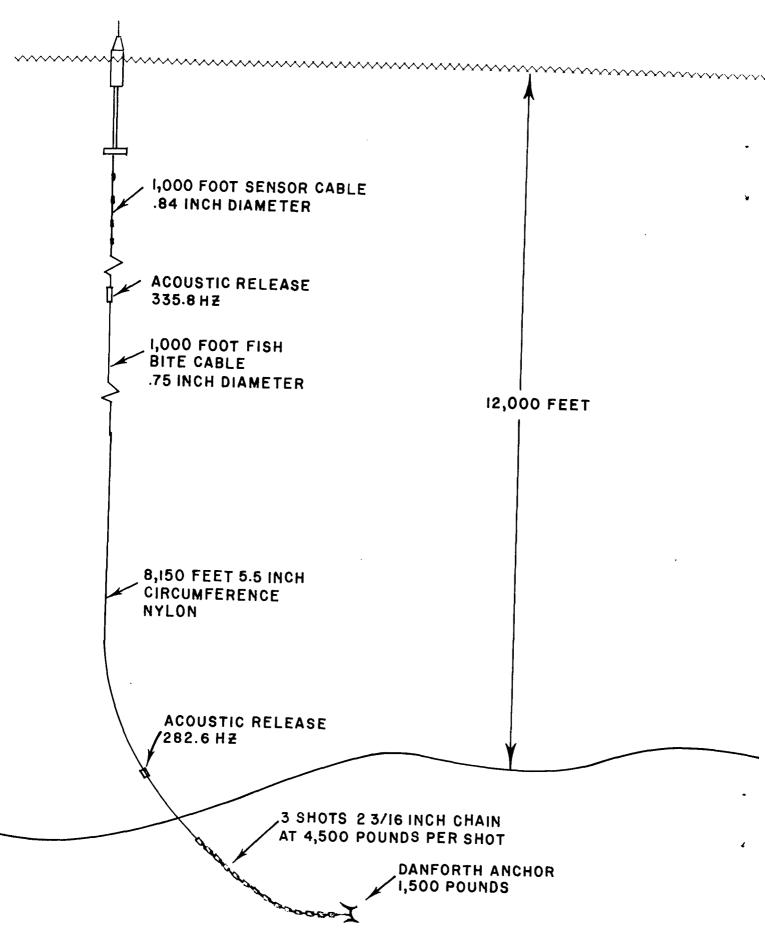
FIGURE 3 MOORING CONFIGURATION

The mooring (figure 3) consists of a 1,000-foot sensor cable, a 1,000-foot fish-bite cable, a section of eight-plaited nylon line, and an anchor chain and anchor. The mooring is a taut-line arrangement with a scope (line length to depth ratio) of 0.8. Two acoustic release mechanisms are provided for retrieval purposes.

The length of nylon line utilized in the mooring is derived from a percent elongation - percent ultimate strength curve to provide the proper mooring tension and scope. The nylon line has a circumference of 5 inches and a breaking strength of 70,000 pounds.

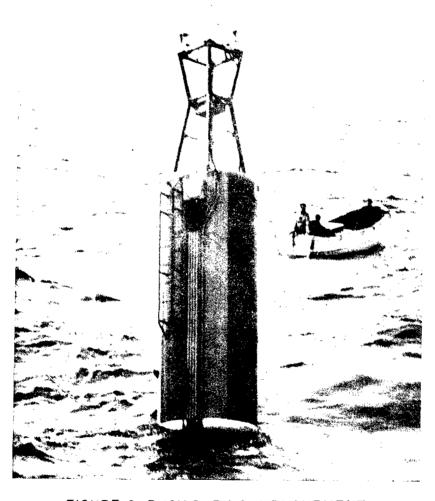
FIGURE 6 BUOY DURING IMPLANTMENT

remainder of the operation proceeded smoothly as sensor cable with attached floats, fish-bite cable, and the nylon mooring line were payed out while the CACTUS' small boat maintained a strain on the buoy (figure 6). After the mooring was deployed (figure 7), except for the ground tackle assembly, the distance between the CACTUS and buoy was minimized to reduce the hydrodynamic forces on the buoy during anchor freefall. Lateral motion of the buoy was not noticeable during anchor freefall. The mooring settled within a short time and was considered successful. The CACTUS remained on site for twenty-four hours to anticipate possible short-term malfunctions. Implant details are as follows:

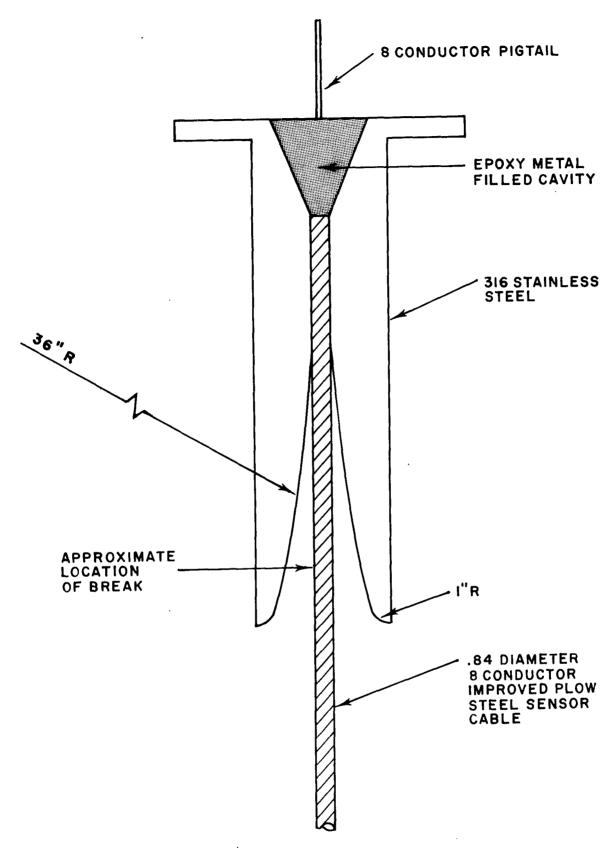
FIGURE 8 SENSOR CABLE BELL MOUTH HOUSING

The CACTUS located and recovered the buoy on 24 February at 31°48'N,65°10'W, approximately nine miles southeast of the implant site. Buoy recovery was conducted without incident. Post-retrieval examination revealed that (1) the sensor cable had failed near its termination in the bell-mouthed housing; (2) a subsurface battery vent hose which failed at its fitting resulted in flooding of the battery housing; (3) a circumferential weld at the interconnecting spar midsection had cracked; (4) the transmitter and data packages in the buoy body were heavily salt

The buoy failed structurally in the following areas: (1) sensor cable failure near the bell-mouthed housing, (2) batteries flooded with sea water, (3) weld failure at spar midsection, and (4) data and transmitter packages salt-water damaged.

The remainder of this discussion analyses environmentally induced structural failures. Preliminary analysis of sensor cable failure indicated that buoy roll probably exceeded the bell-mouthed housing guide radius exit angle (figure 8). This theory is substantiated by observed rolling of approximately 10 to 12 degrees in sea state 4 (4-8 feet) one day after implantment. On several occasions prior to mooring failure, 20- to 30-foot waves were recorded at ARGUS Tower, nine miles from the buoy. Such waves could cause buoy roll exceeding 15 degrees. Because the design motion envelope indicated that maximum buoy roll would be 5 or 6 degrees, the bell-mouthed housing was designed with a 15-degree exit angle. Although the internal radius of the bell-mouthed guide is 36 inches, a oneinch radius at the lip would increase bending stresses (tensile loads) within individual cable wires when the cable overlays the bell-mouth lip. Another possible factor contributing to cable failure was Strouhal effect, that is, strumming of the buoy body and moor. Pronounced strumming was noted on the buoy after implant.

Historically, the weak link of most oceanographic buoys is the electromechanical interface between the oceanographic sensor cable and the buoy body. Although this body system was designed to limit dynamic mooring loads, in situ peak sensor cable load levels may only be inferred. In addition, the buoy motion envelope, specifically in the rolling attitude, was discovered to be far greater than anticipated after implantment. It is therefore difficult to offer an opinion concerning bell-mouth adequacy for this particular buoy system. Perhaps the marriage of the steel cable to a bell-mouth end termination will not function under any design configuration. NOTE: The Monster Buoy has achieved some success using nylon line and a bell-mouthed housing. Future design should incorporate a 125 bell-mouth guide radius/cable diameter ratio for stiff, high tensile strength sensor cables.
